Ultra-Deepwater Production Systems Final Report

Date Report was Issued: August 2005

DOE award number: DE-FC26-00NT40964

**Submitting Organization: ConocoPhillips Company
600 N. Dairy Ashford
Houston, Texas 77079**

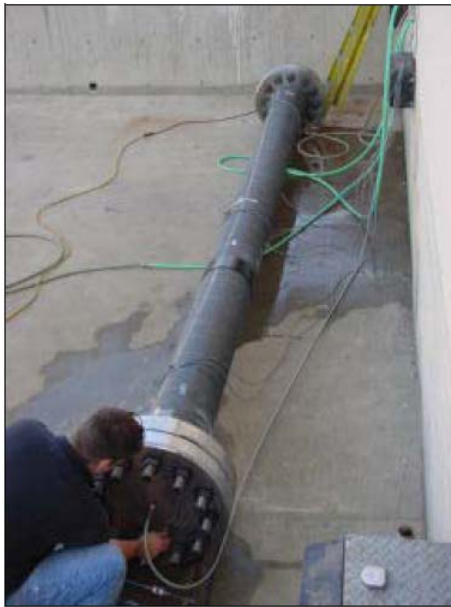
Fig. CPR 5 – CLT-1 Sample

Given the test objectives, CLT-1 was not fabricated to the same standards as a design verification joint. In particular, locally available 4130 steel was used for the MCI's, instead of A707 forged material. The test joint was 20 ft long, with test flange connections at each end, and MCI and composite geometries as used for the original FEA. A number of strain monitors were fitted to the outer layer to record the strain behavior over the multiple pressure cycles. Additionally, prototype "Trip Metal" sensors from StructureMetrix were also installed, to assess the potential for this technology to perform in-service monitoring of the composite. See Fig. CPR 5.

made to maintain the pressure up around 11,250 psi with the test pump, in order to detect the location of the leak. At that stage, the test joint failed in burst.

The autofretage took place uneventfully (although subsequent analysis of test data and comparison with other tests indicate that the metal may have already failed during this cycle). During the second FAT pressure cycle, the joint started leaking through the composite near the test pressure. An attempt was

The failure appears to have initiated in the vicinity of the MCI/Liner weld, then propagated up the MCI ramp, with the composite failing around that area (Fig. CPR 7). Also notable, is the fact that the sudden depressurization of the bore caused buckling (bulge) of the steel liner, as would be expected.

Even though the failure initiated in the metal part, the composite should have been able to contain the burst stresses, although the cutting action of the metal “lips” along the fracture may have weakened the inner hoop fibers and precipitated the composite failure. Still, this

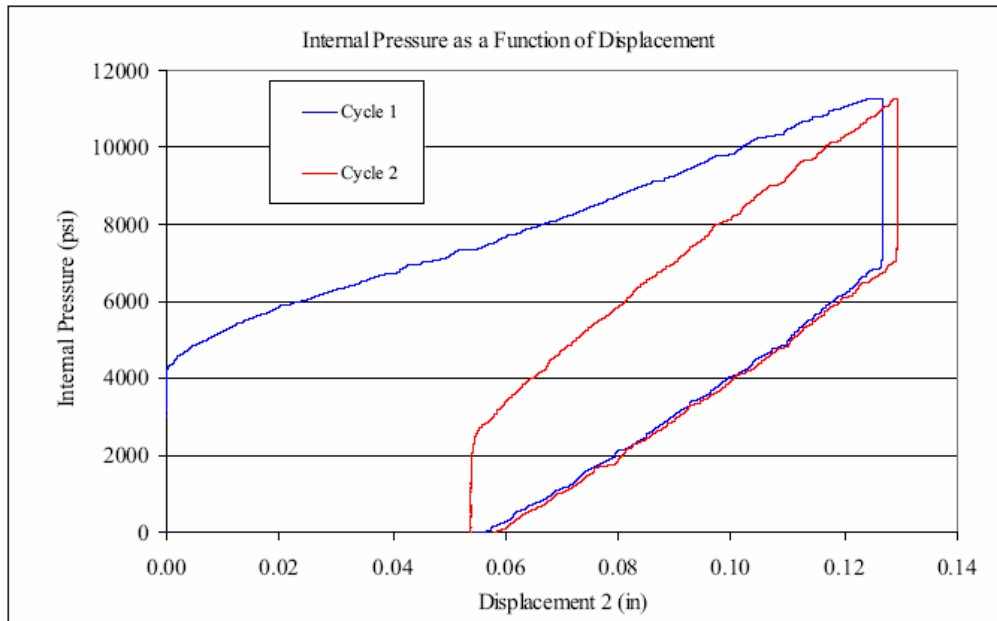
Fig. CPR 6 – Autofretage Effect on Joint Elongation (10 ft Test Sample)

The test sample was taken through the Factory Acceptance Test (FAT) procedure. This consists of two pressure cycles to 11,250 psi. The first one has a short holding period for the "autofretage", during which the steel and composite take their permanent set relative to each other (the steel liner yields), and is in effect part of the manufacturing process. Fig. CPR 6 illustrates the effect of autofretage on the length of a 10-ft long test joint over the two initial pressure cycles. The second cycle verifies pressure integrity of the final product.

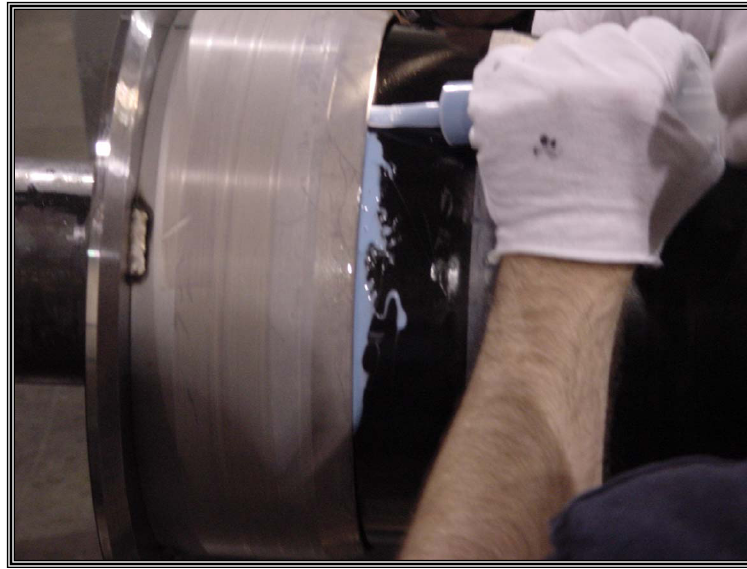
Fig. CPR 10 – Squeezing Sealant into Seal Groove

Examination of the sample after stripping off the composite at the leaking end revealed that the leak path was immediately in-board of the rubber lip seal. The lip seal, a self-energizing concept, is formed by squeezing a sealant material into a thin groove cut axially in the MCI ramp (Fig. CPR 9 and 10). HNBR is then applied over the ramp and bonds to the sealant after curing.

In CLT-2, it was concluded that the bond between sealant and rubber was defective, with many visible voids (Fig. CPR 11). It should be noted that the leak did not go through the lip seal itself. Another observation was that the inside face of the rubber liner immediately above the liner crack bore an “imprint” of the crack. This was attributed to the jetting action of the water as the crack opened. The rubber was only indented, not penetrated.

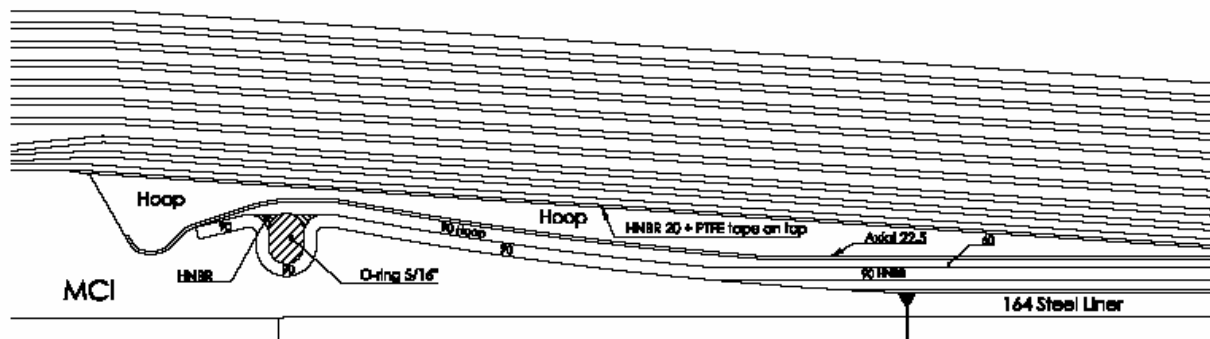
Fig. CPR 12 – “P” Seal

Both concepts were tried on mock assemblies by C4PO, both with inconclusive results. In order to maintain the schedule for delivery to Magnolia, a decision was made to produce two additional 20 ft long “cracked liner” test samples, one – CLT-3 – with the “P” seal, the other – CLT-4 – with the modified lip seal. Like CLT-2, each had a permeable liner in-between steel and rubber liners.

Both CLT-3 and 4 passed the FAT without problem. Unfortunately, when machining the crack on CLT-3, the groove was cut too deep, penetrating the steel liner, and the rubber liner outside was apparently damaged. On the next pressure cycle, the joint leaked. Because of the observed rubber damage, no conclusion could be drawn on the “P” seal effectiveness. The CLT-4 joint was pressured up in stages, with the last “hold” at 8,000 psi. It then leaked out at 9,300 psi. Both joints were depressurized without causing any bulging of the steel liner.

Attempts to patch the rubber liner to allow for further testing were unsuccessful on both joints.

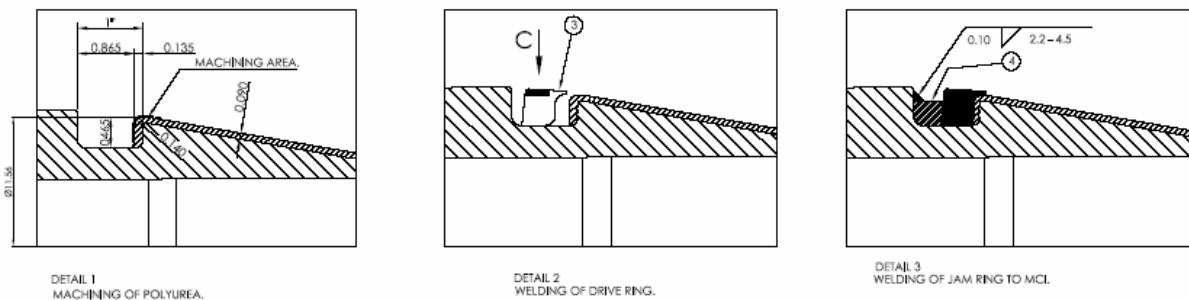
Fig. CPR 13 – “S” Seal Concept

Another rubber seal concept was also attempted, dubbed the "S" seal. This involved machining a square groove around the MCI ramp, then using sprayed Polyurea, instead of sheet HNBR, as the inner rubber layer. The Polyurea was sprayed all the way into the groove, then machined to a controlled groove width. The empty groove space was then filled with two split rings jammed against each other to exert the sealing force against the Polyurea (see Fig. CPR 13).

This concept was first tested on short mock-up assemblies and showed enough promise to be incorporated on further test joints. However, it proved to be highly sensitive to any deformation of the seal groove (which would de-energize the seal) and produced mixed test results. It was eventually replaced by the Greene Tweed seal for the field joints (see Section 14).

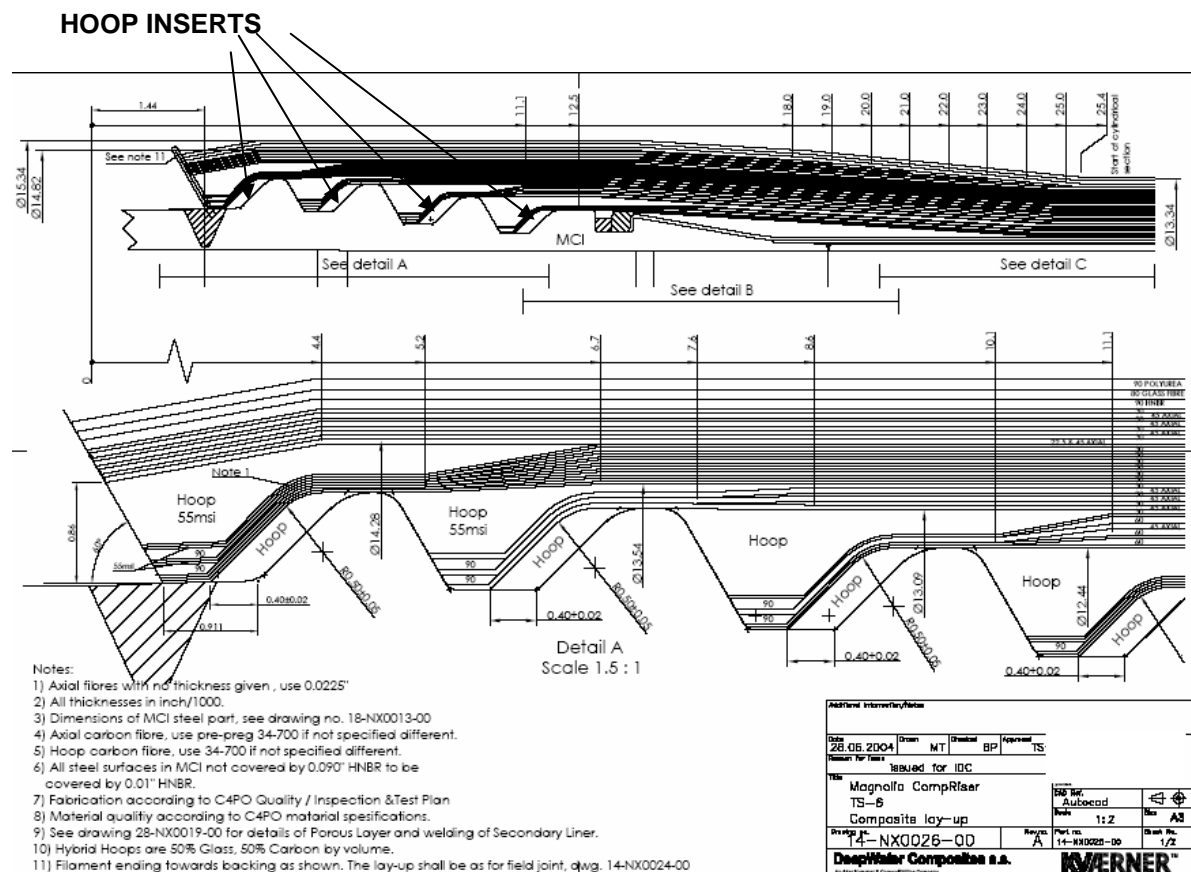
Fig. CPR 14 – 4-Trap MCI with Hoop Inserts

originally developed by Grover Engineering. The results of this work raised concerns on whether the axial capacity requirement (2500 kips) could be met with sufficient certainty using the existing design. Alternative composite and MCI layouts were modeled, with the ultimate recommendation to change to a 4-trap MCI configuration. Also, this work showed that a “hoop insert” on the load ramp of the MCI grooves (Fig. CPR 14) would be required, in addition to the fourth trap, to increase the laminar shear capacity across the traps. The hoop insert manufacturing feasibility was demonstrated on the CLT-3 test sample. These recommendations were adopted, and new (longer) MCI forgings were ordered.

The hoop insert comparative advantage was verified by fabricating two short test samples, with single trap MCI’s (referred to as the “Hoop Insert Verification” samples in the appendices). One sample incorporated the hoop insert, the other not. Axial fiber configurations were identical for both. The two configurations were simulated in the FEA model to predict the axial load capacities. Each sample was then subjected to axial load tests, including “hold” periods to evaluate static fatigue (creep), then pulled to failure, with the following results:

<u>FEA Prediction</u>	<u>Test (failure)</u>
No hoop inserts	> 325 kips	498 kips
With hoop inserts	> 550 kips	704 kips

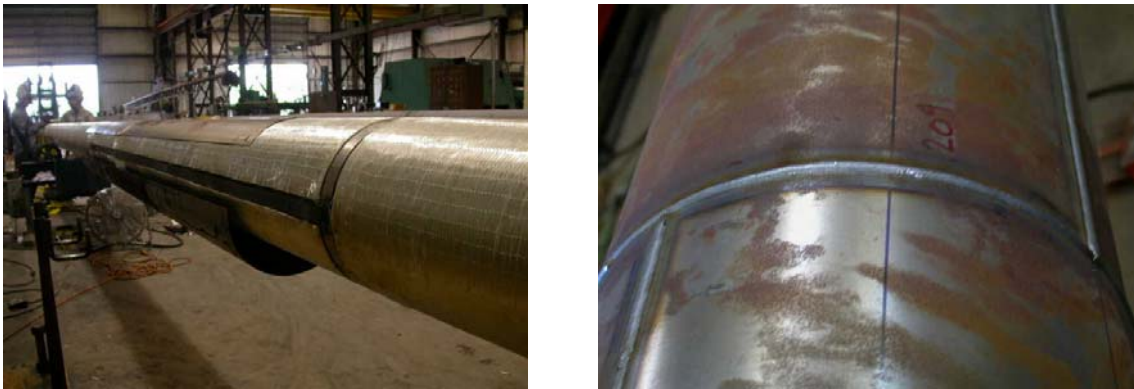
Fig. CPR 19 – Secondary Liner Fabrication

Another short test joint, TS-4, was then fabricated based on the revised design. It also included the secondary steel liner and “S” seal. The secondary liner consists of 0.049” thick steel sheets (approx 30 ksi yield) formed and welded around the primary liner and dry fiber permeable layer, in 8 ft sections. At each end, this liner is also welded to the MCI in order to complete the seal. See Fig. CPR 19.

DeepWater Composites contracted for a number of tests of various materials' susceptibility to water jetting action. The conclusion of this study was that the only practical solution to meet the project time frame was to "double hull" the tube with a second, thinner, steel liner. It should be noted that the high pressure failure on CLT-4 was actually fortuitous, as the water jetting failure mode would otherwise have been completely missed (it had not been identified by the risk analysis).

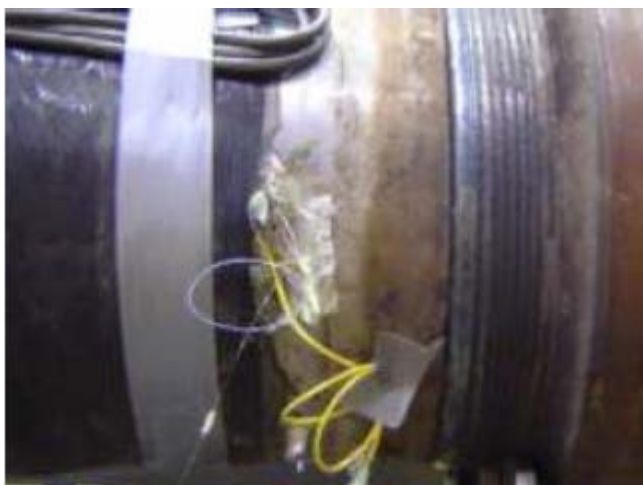
Fig. CPR 23 – Optic Cables Exiting Composite

In spite of the attempts by the two suppliers to design and provide a robust fiber optic sensor assembly, several sensors failed. This makes the use of the fiber optic sensors

questionable without additional developments and excessive redundancy. In addition, a concern was raised regarding the penetration of the fiber optic cable through the composite and the risk of water leaking into the composite around the penetration (Fig CPR 23). Both of these issues contributed to the decision to eliminate the fiber optic sensors as an option for the Magnolia CPRs.

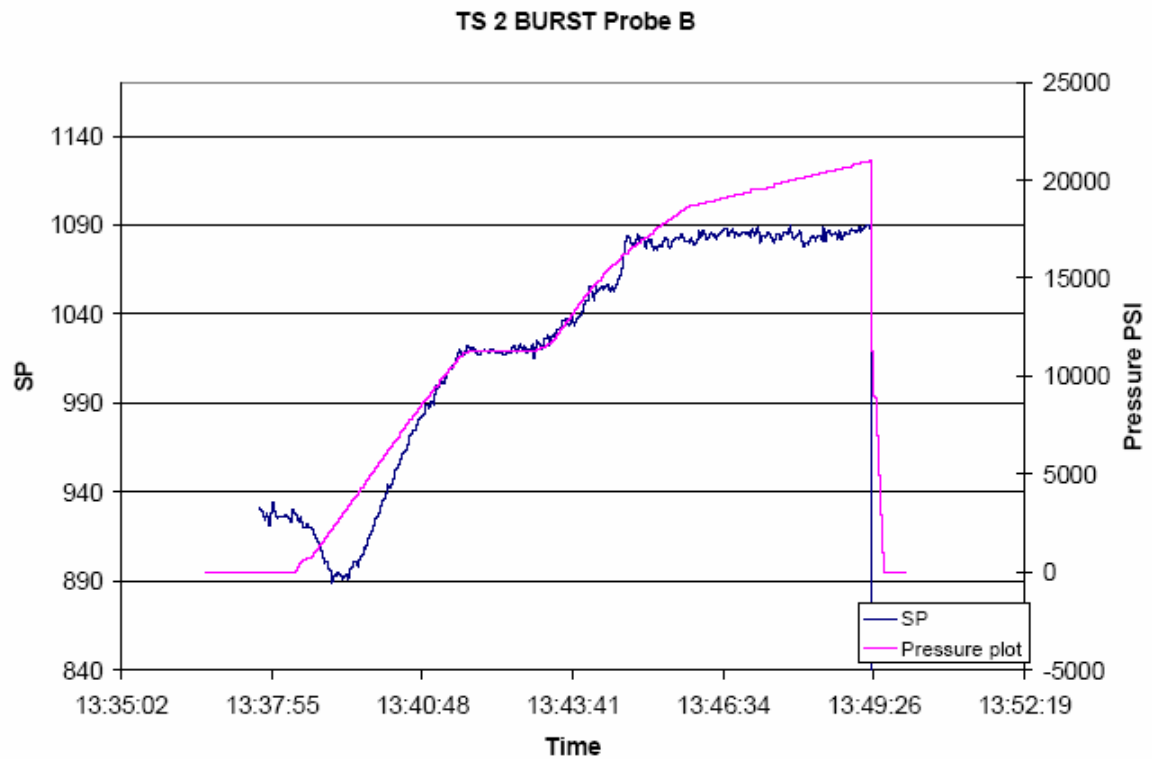
Fig. CPR 27 – StressProbe Response (TS-2 Burst Test)

The results have shown that the magnetic permeability steel sensors offer the best approach for monitoring the integrity of the production riser joints. While the sensors are available, actual in-service monitoring will require an additional effort to develop an ROV deployed monitoring probe to interrogate the sensors.

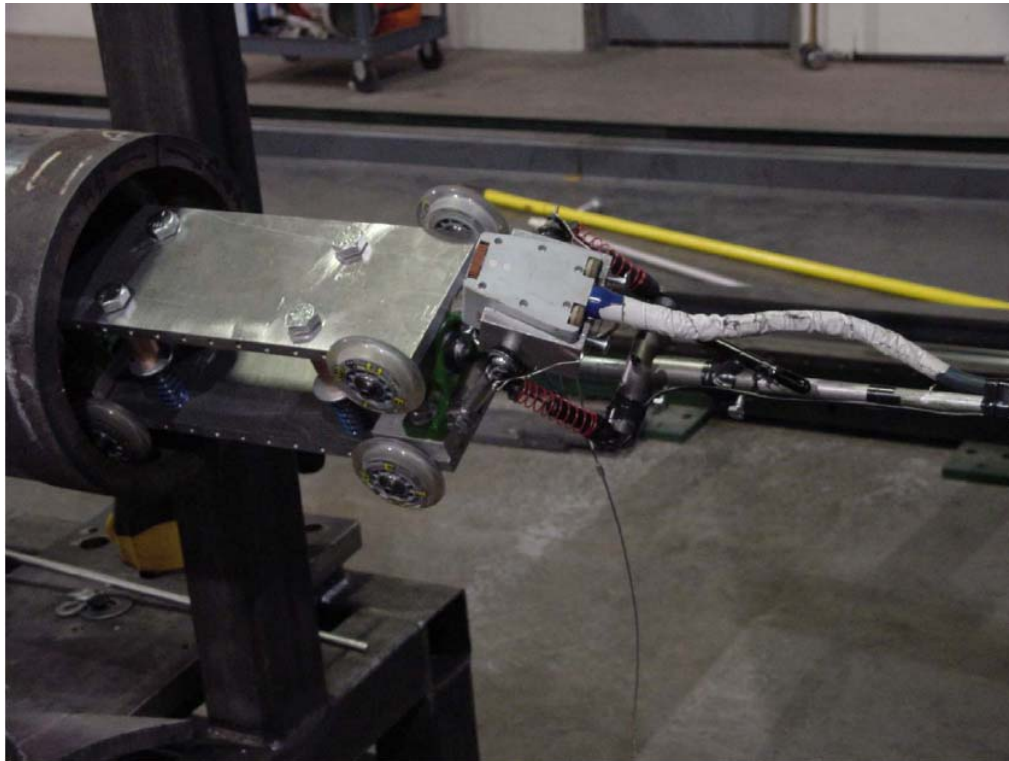
Fig. CPR 32 – C4PO Camera Crawler with ACFM Probe

The ACFM was then tried on the inner liner girth weld of cutout sections from CLT-7 and other test pieces. It proved to be quite accurate in detecting weld defects, including dimensions. The remote camera carrier was therefore modified to enable inspection of the inner liner girth welds with the ACFM probe (Fig. CPR 32). In the seven remaining metal assemblies, a total of thirteen indications were detected. Twelve were shallow, and, after some grinding, were determined to be caused by the heat affected zone from the secondary liner to MCI weld. The most pronounced indication was 13 mm long x 1.3 mm deep and could not be ruled out. That metal assembly was rejected.

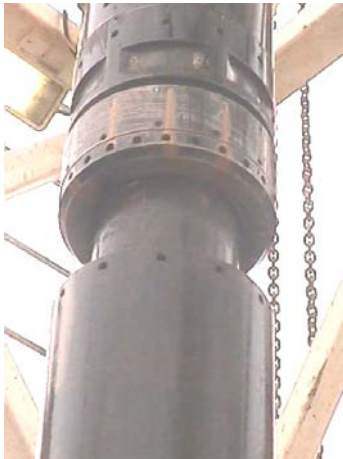
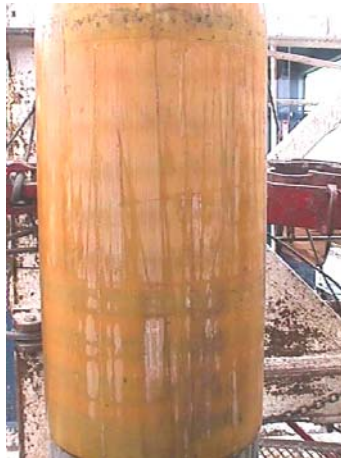
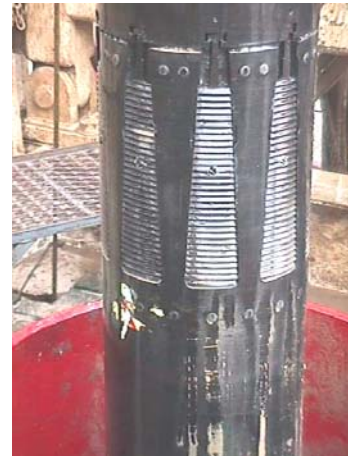
Fig CTLD-6

After pulling out the assembly and returning it to the shop, the ball was dropped and the liner hanger set, proving that the mechanism is robust. External inspection indicated no significant wear anywhere (Fig CTLD-6). Upon tear-down, however, there were some negative findings that were addressed. The most significant was the failure of a seal in the liner hanger running tool. This allowed mud into the running tool, and the barite in the mud settled out within the tool, locking up some of the mechanisms (Fig CTLD-7). This was redesigned so that the mechanism was contained in a pressure-balanced oil bath. The DCS seal had several missing wear inserts (Fig CTLD-8), so the shape of these inserts was changed from cylindrical to spherical. The liner was also inspected, and several joints required recutting.

Mud Filter of DCS

Translating Seal
Of DCS

Liner Hanger
Slips

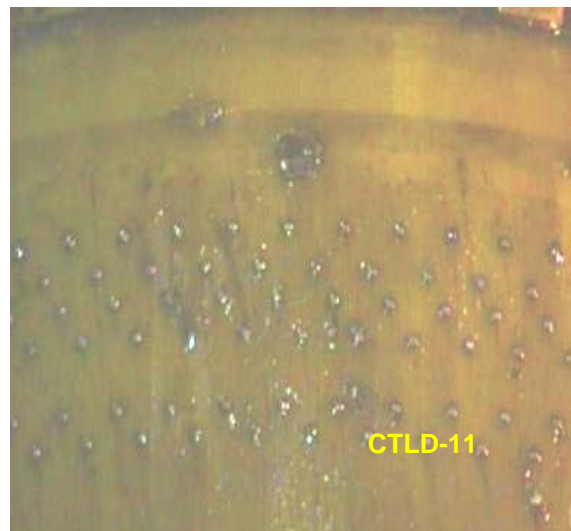
- The changes to the inserts in the DCS element worked perfectly; none was lost (Fig CTLD-11).
- A ZX seal element had been peeled off through contact with the casing wall. The cause was the translation of the setting cone when the vibrations sheared the set pins (Fig CTLD-12).
- There was erosion on the inside of the outer closing sleeve over the reversing port. This occurred because the vibrations allowed the set pins holding the sleeve in place to vibrate loose, and the sleeve began closing on its own across the reversing jet.
